**REC-ERC-89-4**

# **INVESTIGATION OF ALKALI-SILICA REACTIVITY IN FOUR DAMS IN THE SOUTHEASTERN UNITED STATES**

**July 1989**

**U. S. Department of the Interior  
Bureau of Reclamation**

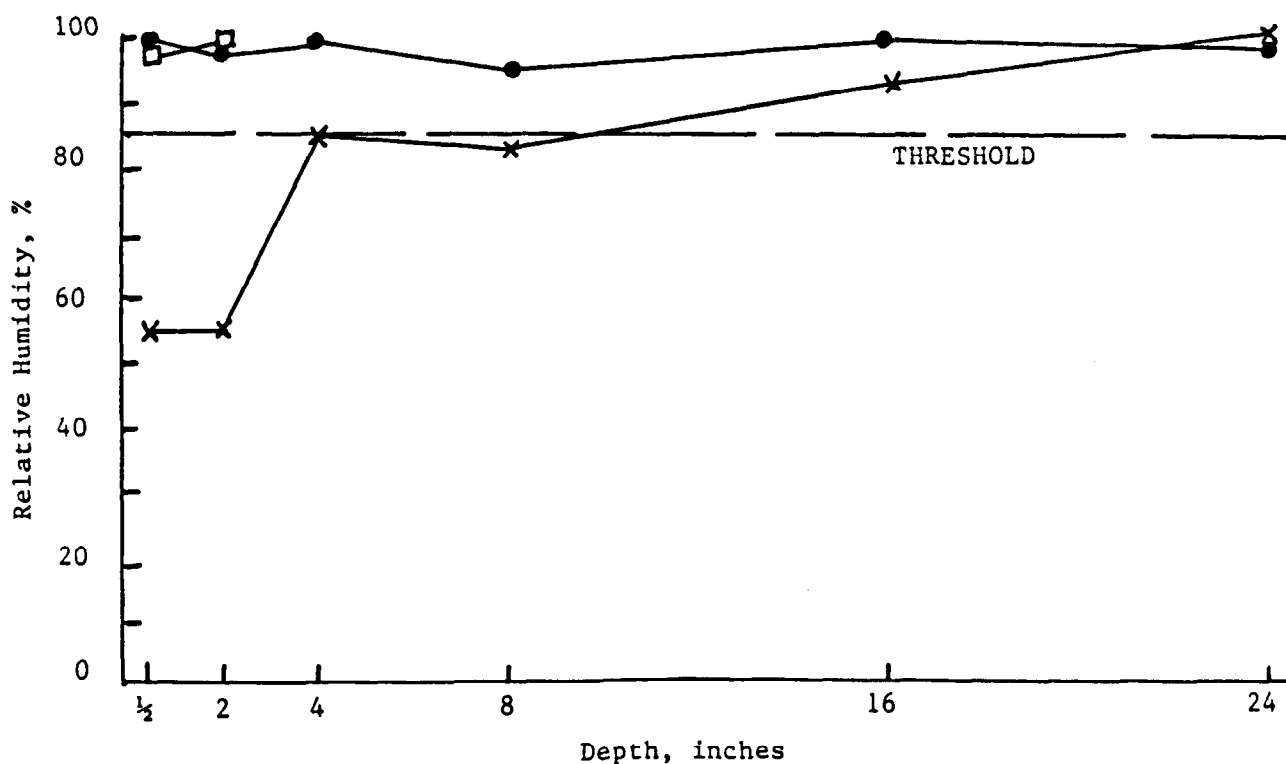
Figure A1. — Relative humidity data for Fontana Dam Concrete.

**Relative Humidity Measurements.** — Results of relative humidity measurements are given on figure A1 in appendix A. These results indicate that, except for near-surface concrete at one location, concrete from exposed surfaces inward is sufficiently damp to permit expansive alkali-silica reactivity to occur. Concrete in the adit at elevation 1315 was at or near 100 percent relative humidity (referenced to 70 to 75 °F) from the exposed surface inward to the 24-inch depth. This is well above the 80 to 85 percent relative humidity threshold level required for expansive reactivity. In the adit at elevation 1700, concrete from the exposed surface inward to a depth of 4 inches increased from 55 to 85 percent. At greater depths up to 24 inches, relative humidity values gradually increased to 100 percent.

These three locations were considered to characterize the range of moisture conditions in the dam. Thus, essentially all of the concrete in the dam is considered to be sufficiently damp to permit expansive reactivity to occur, provided other reactivity requirements are met.

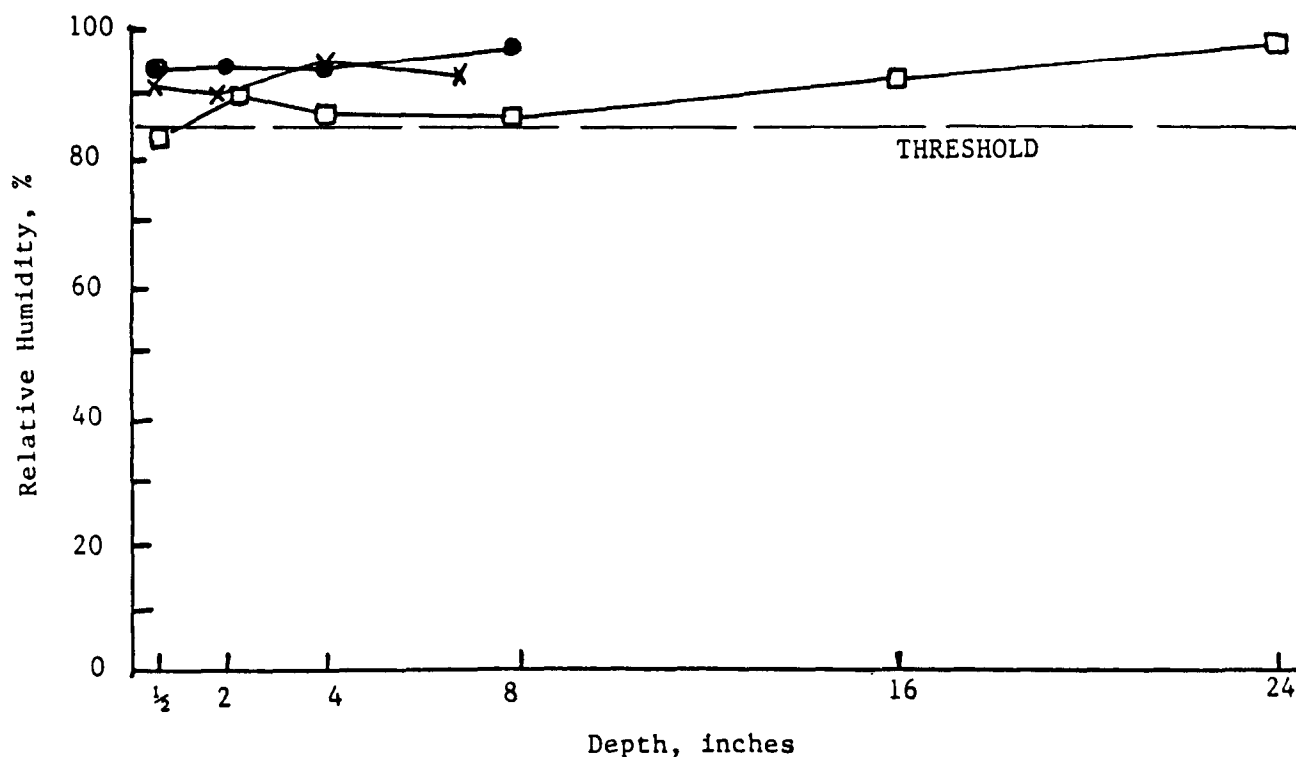
Figure B1. — Relative humidity data for Hiwassee Dam concrete.

**Relative Humidity Measurements.** — Results of relative humidity measurements are given on figure B1 in appendix B. These data indicate that concrete at depths from exposed surfaces inward are sufficiently damp to sustain expansive alkali-silica reactivity. This is evidenced by all relative humidity values being at or above the 80 to 85 percent threshold level required for expansion to occur. Based on these investigations, these high relative humidity values would be expected to be encountered only at depths greater than about 6 to 12 inches from exposed surfaces. However, relative humidity values for the 15-inch-thick wall along the roadway at the top of the dam also were well above the threshold level. This indicates that little or no long-term atmospheric drying can be expected at this damsite.

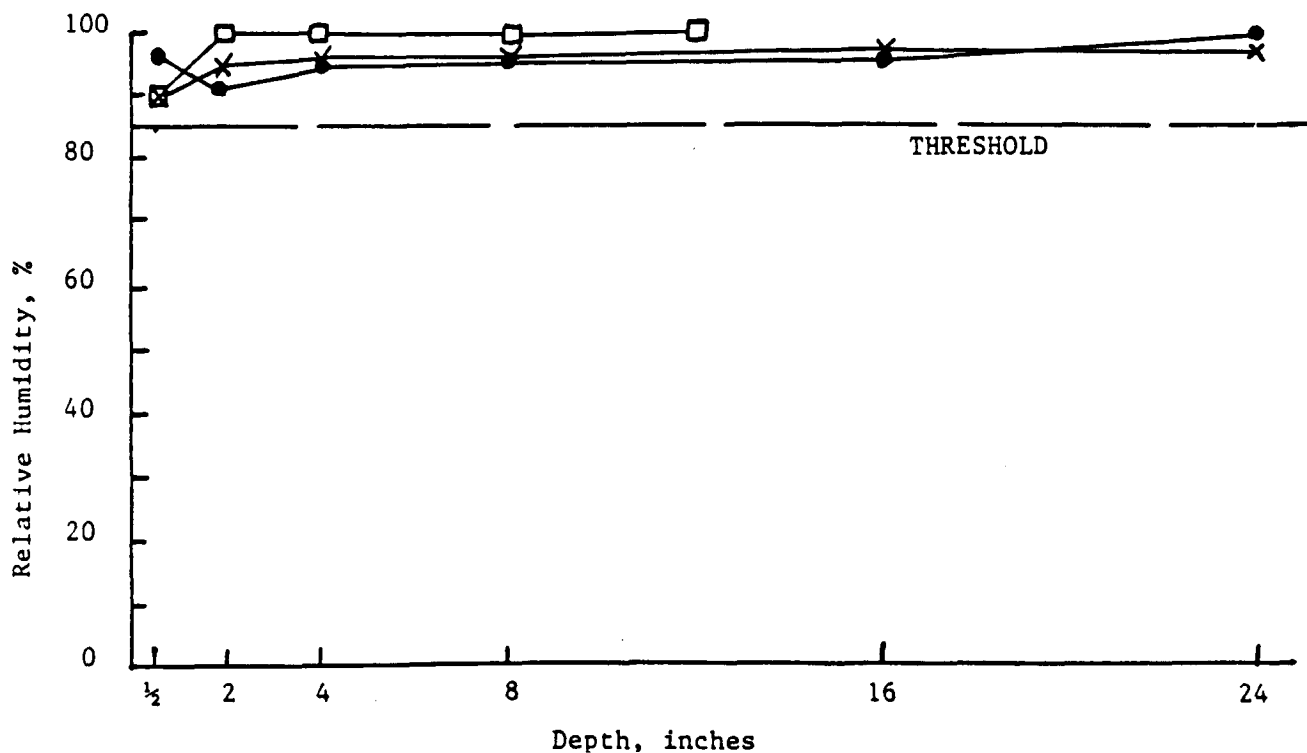
Figure C1. — Relative humidity data for New Savannah Bluff Lock and Dam.

**Relative Humidity Measurements.** — Results of relative humidity measurements are given on figures C1 and C2 in appendix C. At all locations, relative humidity values were uniformly high and well above the 80 to 85 percent threshold level required for expansive reactivity. Only in surface concrete up to the 2-inch depth were relative humidity levels slightly below those at greater depths up to 24 inches. The trend in the curves indicates that concrete at depths greater than 24 inches is at 95 to 100 percent relative humidity. Since it is believed that the locations sampled include the range of moisture conditions at this site, it is concluded that concrete in the lock and dam structure is still sufficiently damp to permit expansive alkali-silica reactivity to occur.

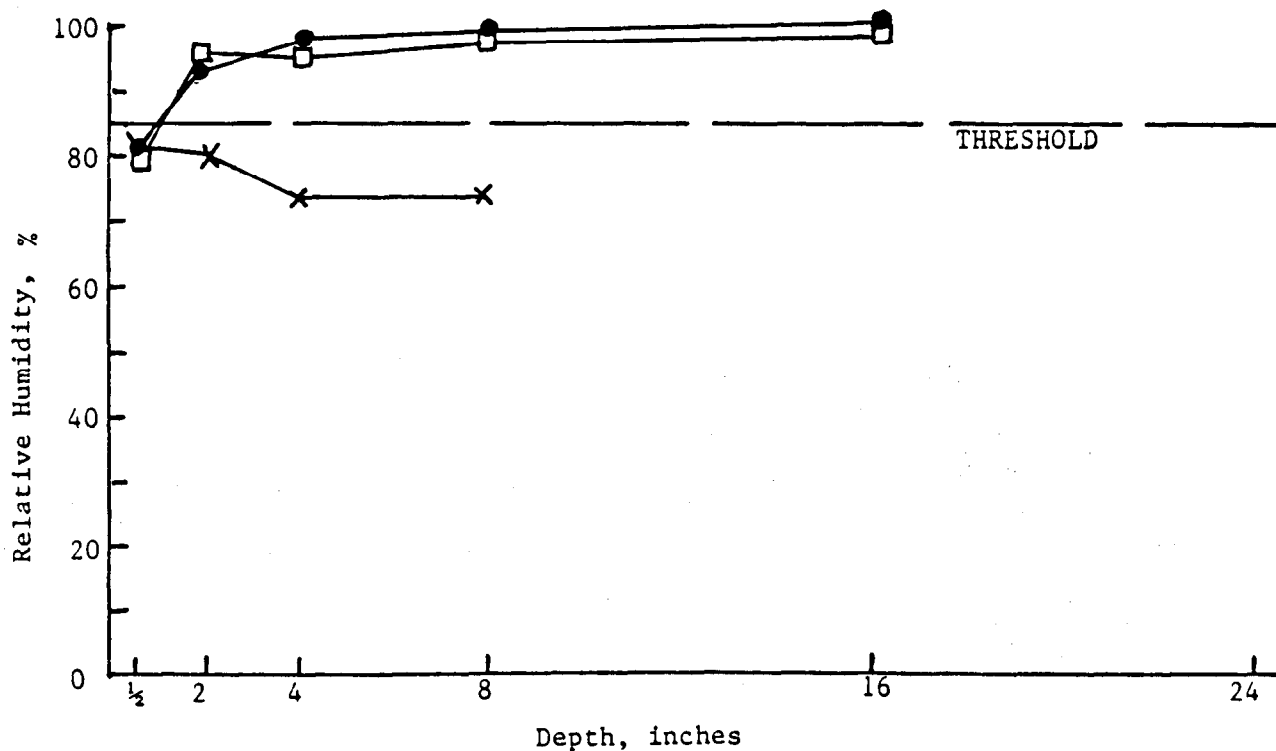
Figure D1. — Relative humidity data for Oliver Lock and Spillway concrete.

**Relative Humidity Measurements.** — Results of the relative humidity measurements are given on figure D1 in appendix D. At locations in the landside and in the riverside lock walls, relative humidity values increased from about 80 to nearly 100 percent within 2 to 4 inches from top exposed concrete surfaces, and remained at that level to the 16-inch maximum depth sampled. This trend in the data indicates that concrete at these and greater depths is sufficiently damp to support expansive reactivity if other requirements are met. In contrast, data for the sample location in the landside lock wall, about 10 feet below the top surface, indicate relative humidity values ranging from about 70 to 80 percent up to the 8 inches depth. This is sufficiently dry to preclude expansive reactivity at least up to this depth. From the trend indicated on figure D1, based on previous experience, it is likely that relative humidity values exceed the 80 to 85 percent relative humidity threshold level at greater depths, thus permitting expansive reactivity to occur.

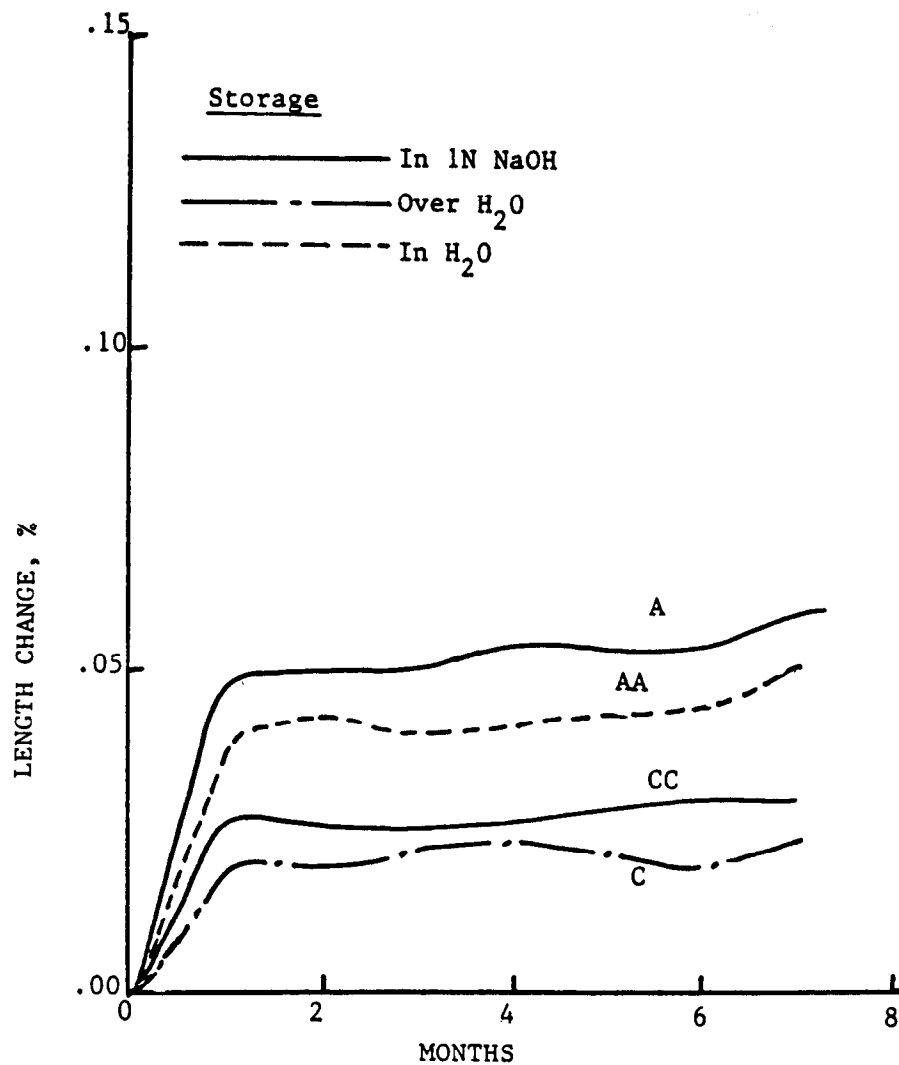
Figure D2. — Length change of cores stored under various conditions, Oliver Lock and Spillway.

shows that cores immersed in 1N NaOH solution produced only slightly greater expansions than cores stored in or over water. This indicates little or no potential for further expansive reactivity in these cores. This may be due to lack of available alkali, and possibly to a lack of remaining unreacted but potentially reactive aggregate. After initial expansions, which were due to uptake of moisture from the dried condition, core lengths remained relatively stable.

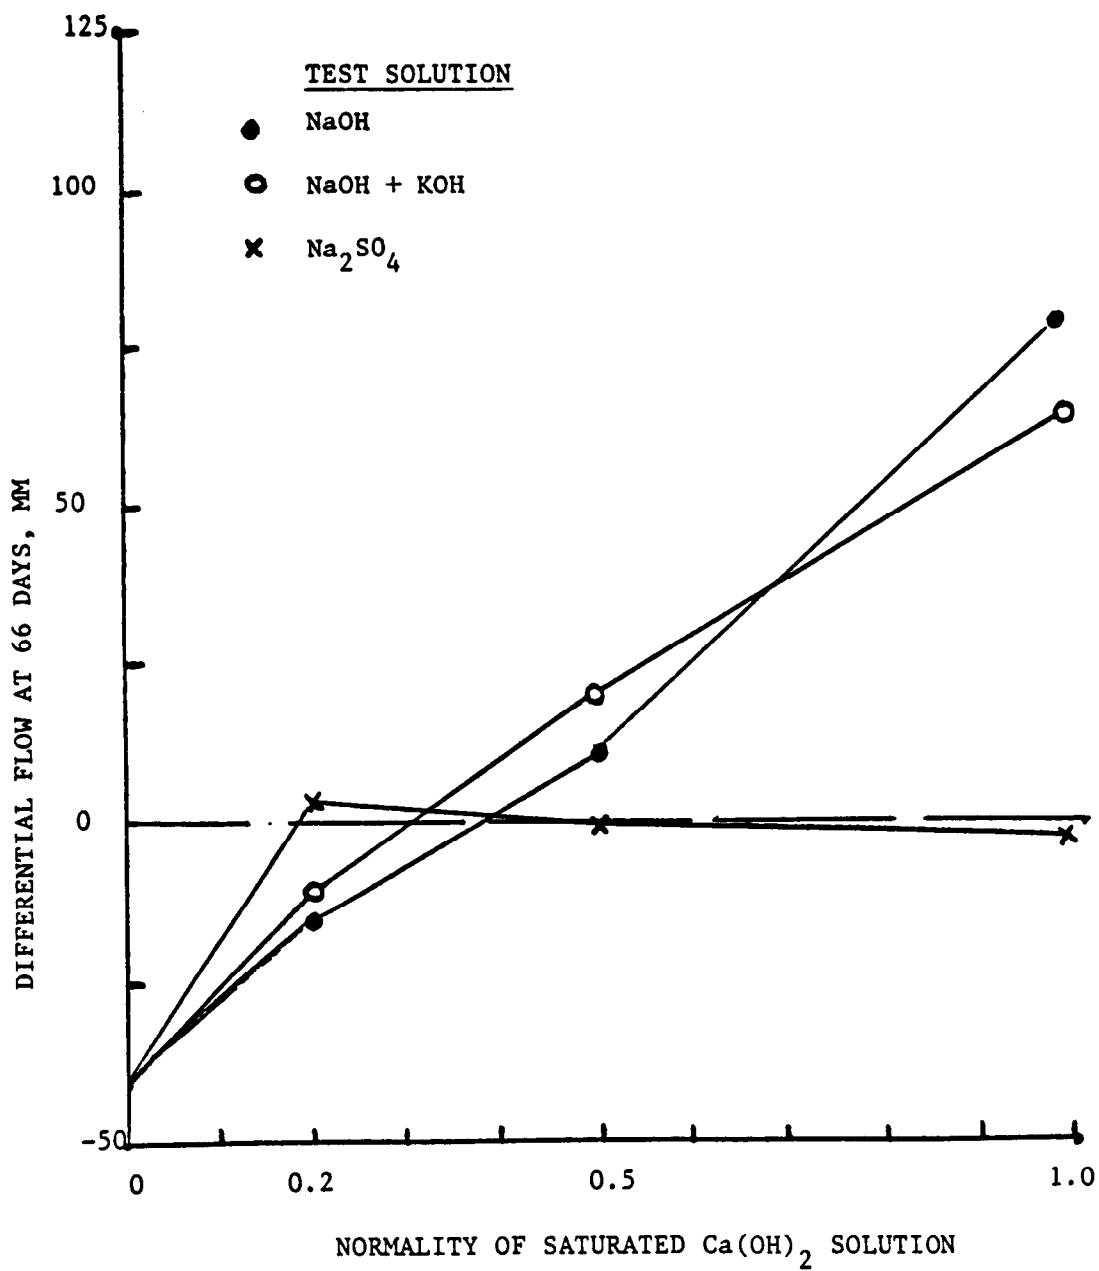
Figure E4. — Effect of concentration of  $\text{OH}^-$  or  $\text{SO}_4^{2-}$  concentration on flow rate.

Figure E4 shows the relationship between normality of the various solutions and differential flow at 66 days. As indicated, a straight line relationship exists between NaOH and NaOH + KOH normality and flow. This reflects the effect of increasing OH ion concentration as noted above. The plot also indicates that no flow occurred with Na<sub>2</sub>SO<sub>4</sub> regardless of sodium ion concentration within the range studied. Thus, sodium concentration, by itself, is not necessarily a measure of tendency to expansive reactivity in concrete.
